February 25, 2011

Waste Management of Hawaii  
Waimanalo Gulch Sanitary Landfill  
92-460 Farrington Highway  
Kapolei, Hawai'i 96707

Subject: Liner Damage Assessment, Repair, and Construction Quality Assurance Report  
for Cell E6 Sideslope, Waimanalo Gulch Sanitary Landfill, Kapolei, HI

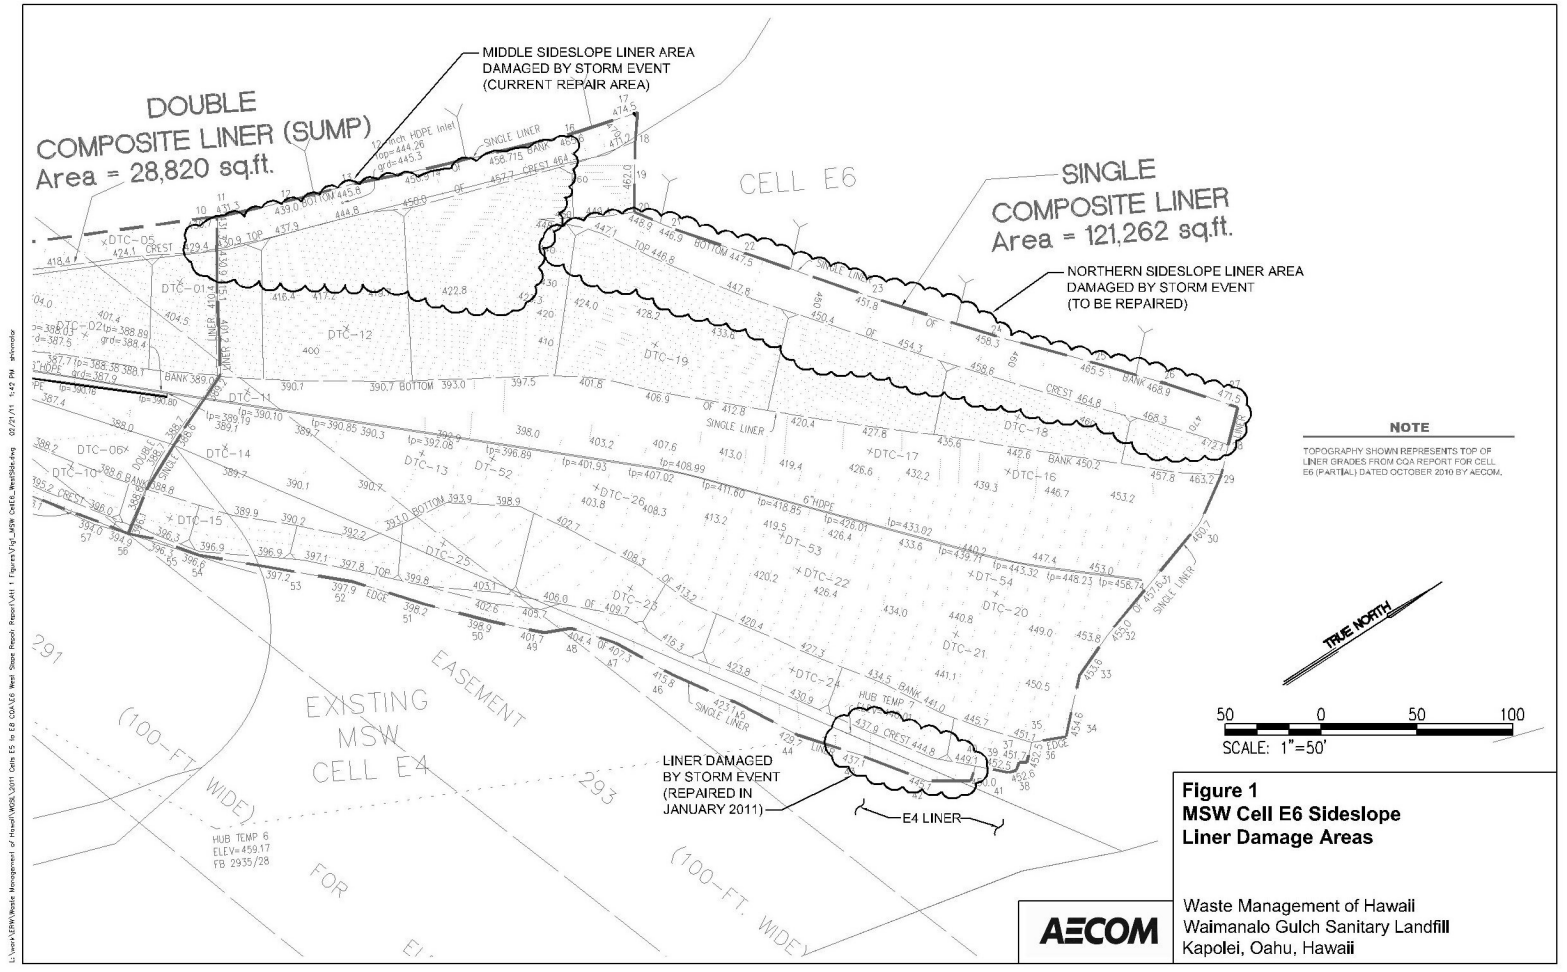
**Figure 1**  
**MSW Cell E6 Sideslope**  
**Liner Damage Areas**

In late December 2010, a series of storms produced high run-on at the site resulting in damage to the northeastern edge of the MSW Cell E6 liner where it joins with Cell E4. Another large storm arrived on the evening of January 12, 2011 that resulted in additional flooding of the landfill and damaged the exposed portion of the western sideslope area of the MSW Cell E6 liner system. The damaged areas are shown on Figure 1, Attachment 1.

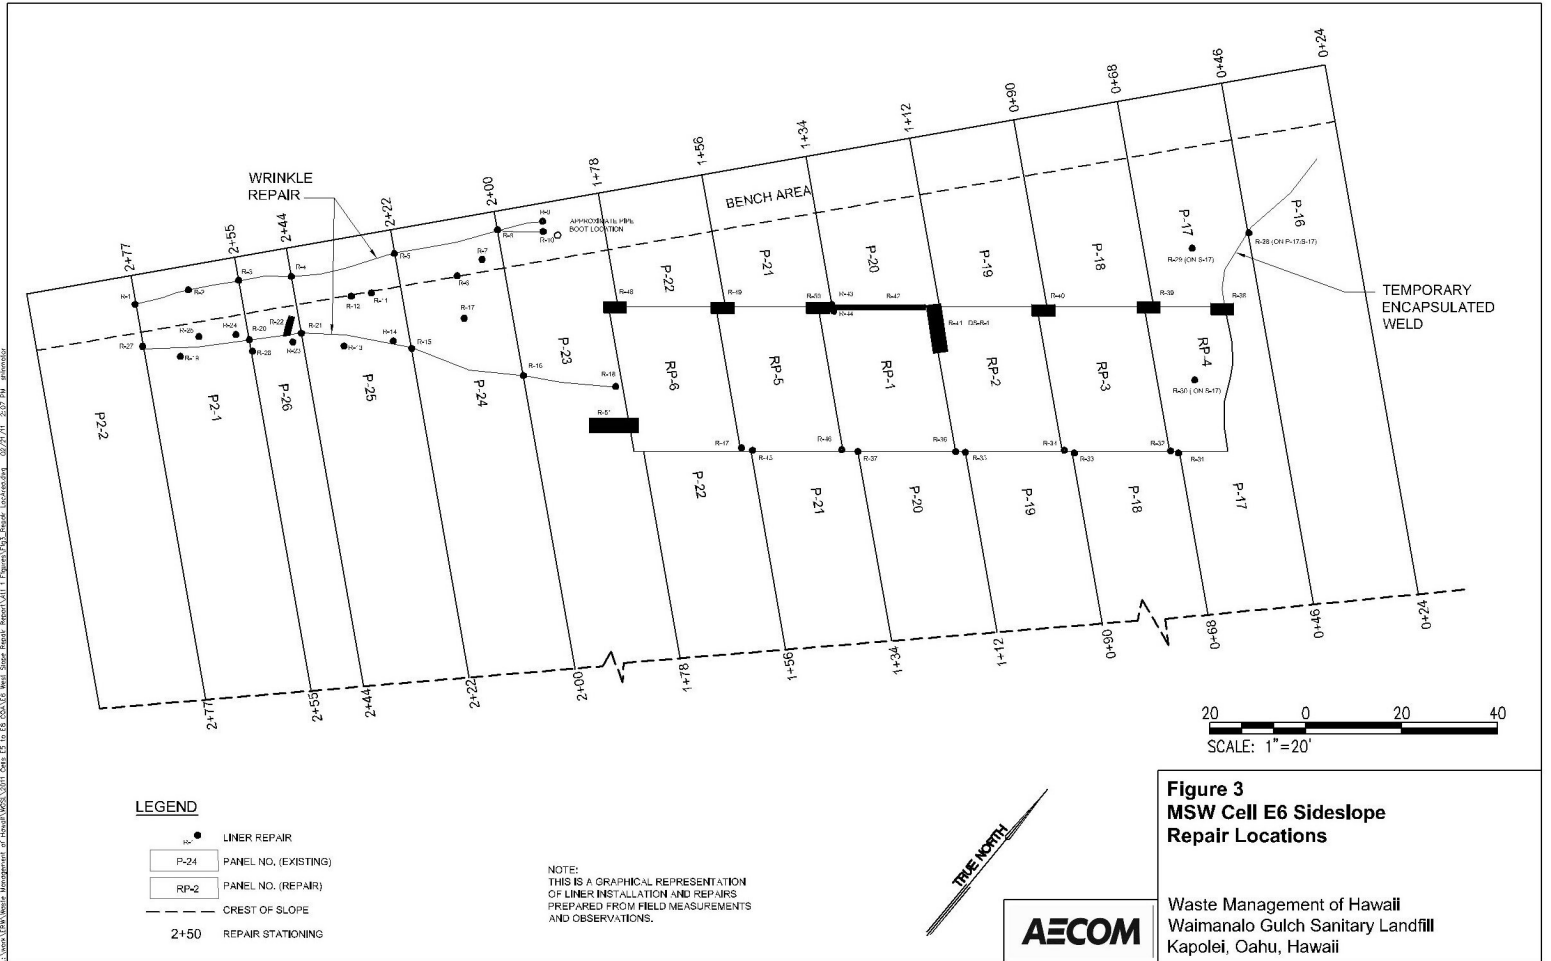
Work began on February 3, 2011 to repair the wrinkles and expose the sections of the sideslope liner that contained hydrated GCL. Repairs were completed on February 17, 2011. An excavator and hand labor were used to carefully remove any MSW, operations layer, and sediment off of the liner system so it could be inspected. Inspection holes were cut through the multiple layers of the liner system to determine if the GCL had been hydrated and where sediment had been deposited. This uncovering process continued until all damaged areas were exposed in the middle area of the sideslope. No damage to the subgrade cushion soil was observed during the inspection. The area requiring repair is shown on Figure 2, Attachment 1.

The repair area and repair locations are shown on Figure 2 and Figure 3 in Attachment 1. The area is along the sideslope area of Cell E6, corresponding to originally installed panels P2-1 through P-16 (60-mil panel numbers), and is approximately 250-ft long in the north-south direction and 70-ft wide in the east-west direction. Repairs to the geomembrane were made at locations where the liner was physically damaged during the storm events, in addition to areas cut to remove wrinkles, sediment, or hydrated GCL.

Once the damaged liner area was fully delineated, repairs were conducted to remove any wrinkles, hydrated GCL, and trapped sediment between the liner system layers. Following removal of damaged liner material, the liner system components were replaced with new material. Details of the repair activities and CQA observations are presented in Section 3.0. Areas to the north and south of the repair area will be uncovered later in 2011 when rockfall hazards/sediment are removed and these conclusions can be verified.

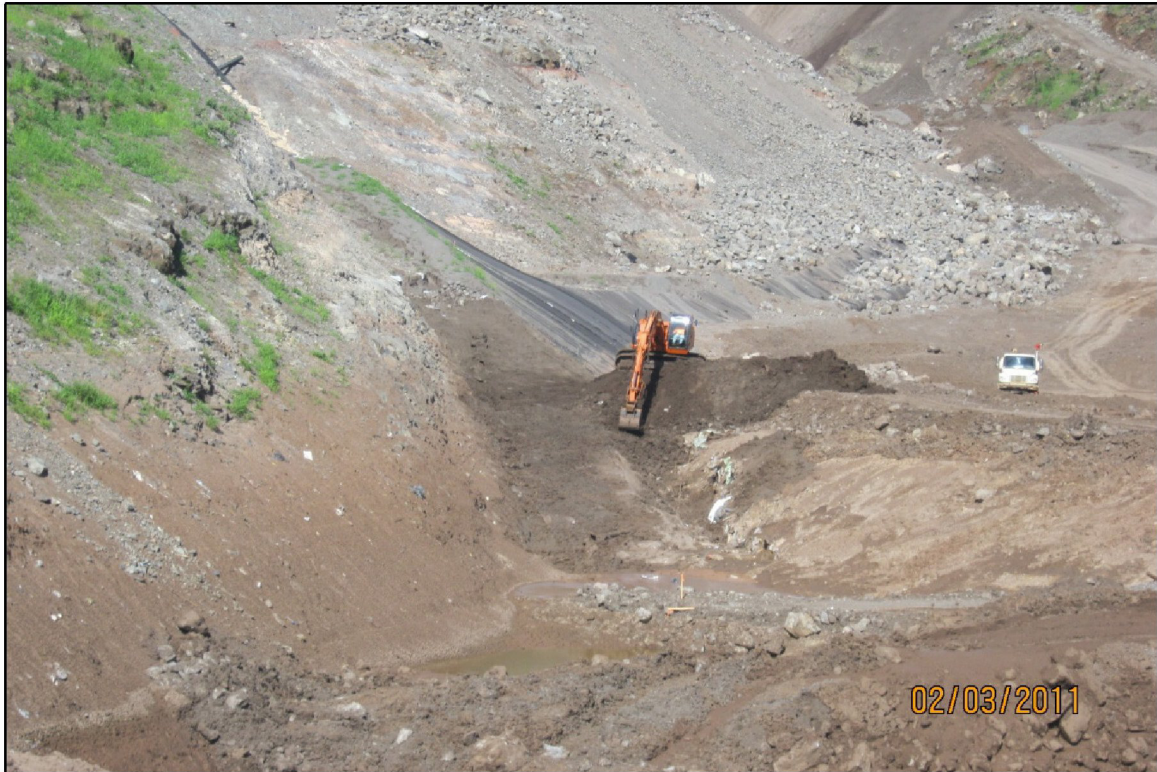
Photo 1: Excavator removing sediment along sideslope to expose wrinkles in liner north of the sump.

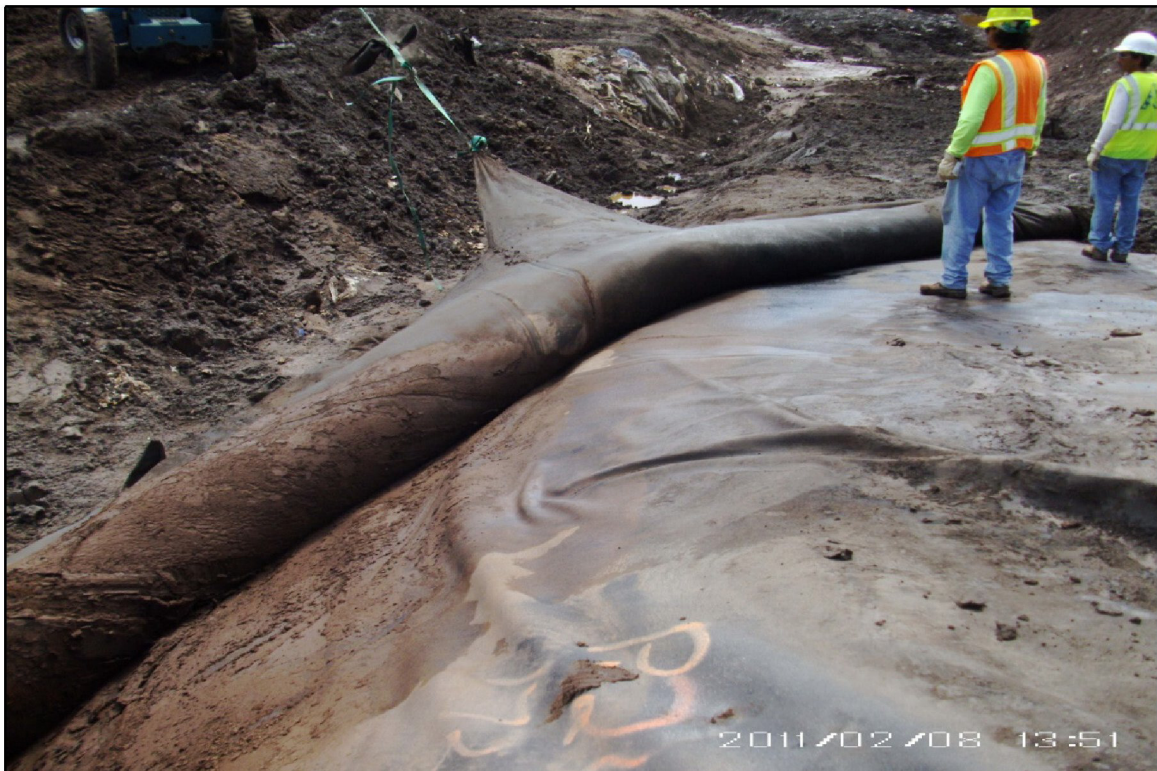
Photo 2: Removing 16-oz/yd<sup>2</sup> geotextile/sediment to expose wrinkles in 60-mil geomembrane.

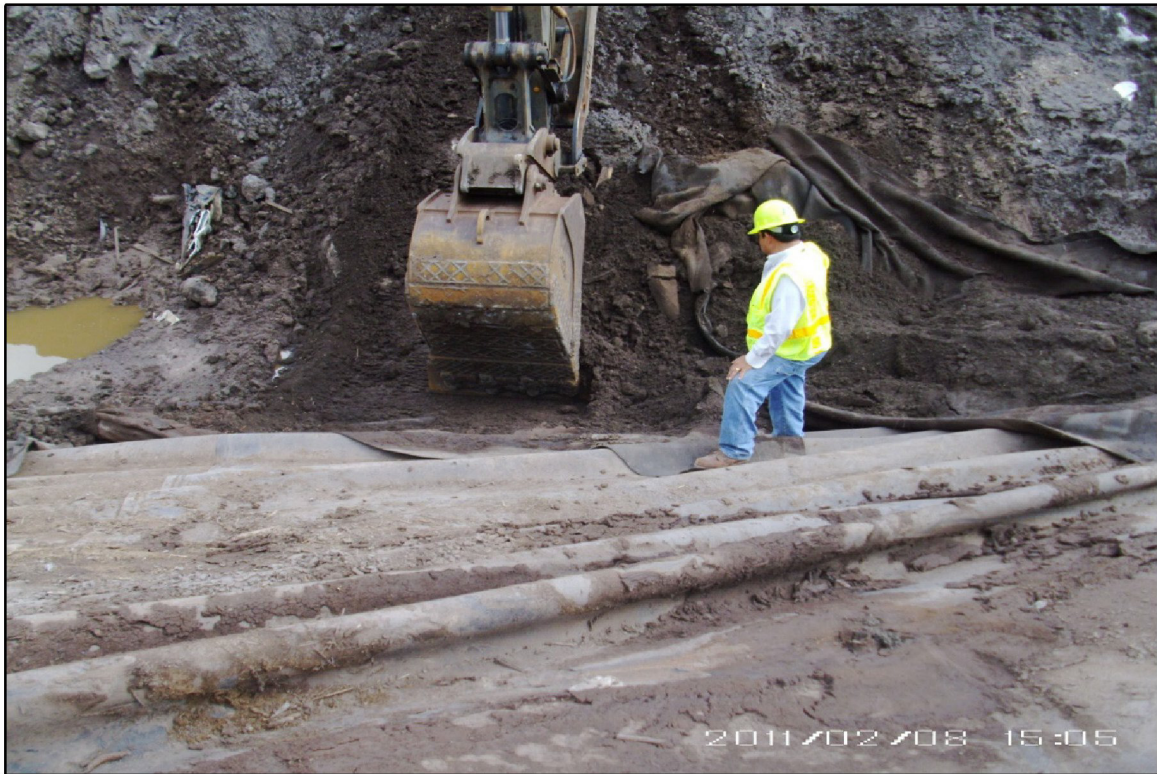
Photo 3: Excavator removing sediment at toe of MSW slope to expose wrinkles in 60-mil geomembrane.

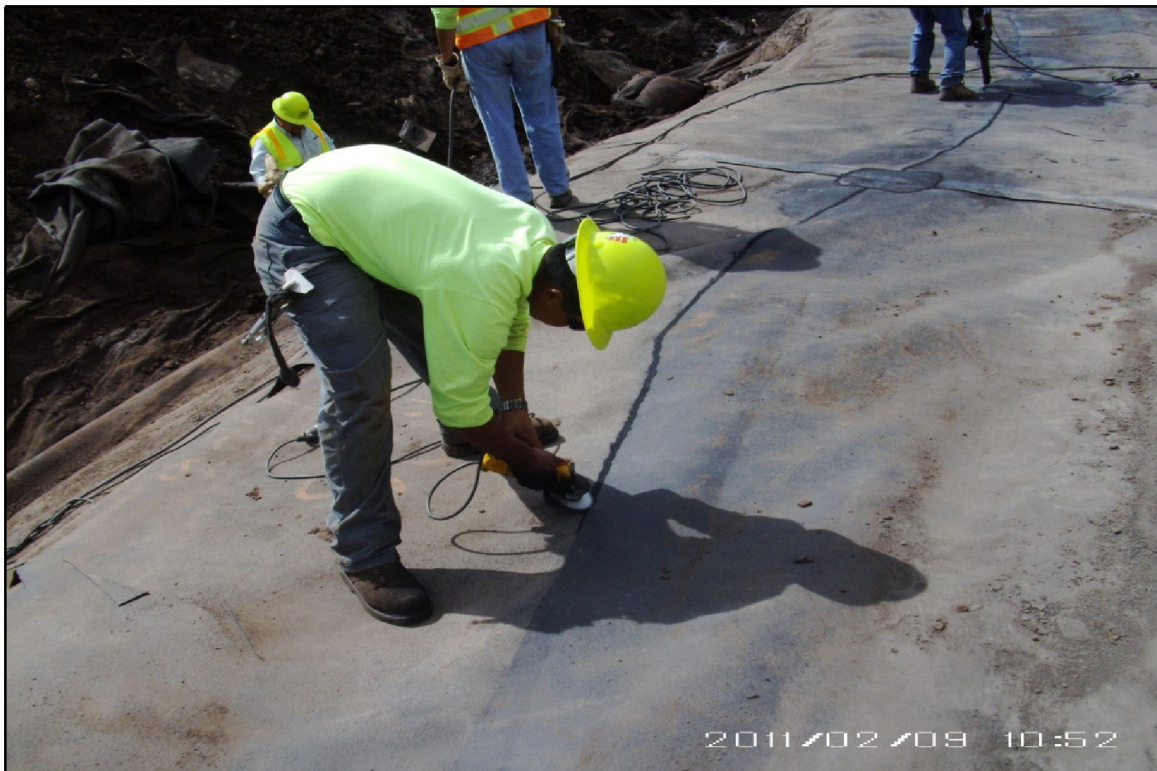
Photo 4: Preparing seam for extrusion weld with a grinder following removal of the wrinkle in 60-mil geomembrane.

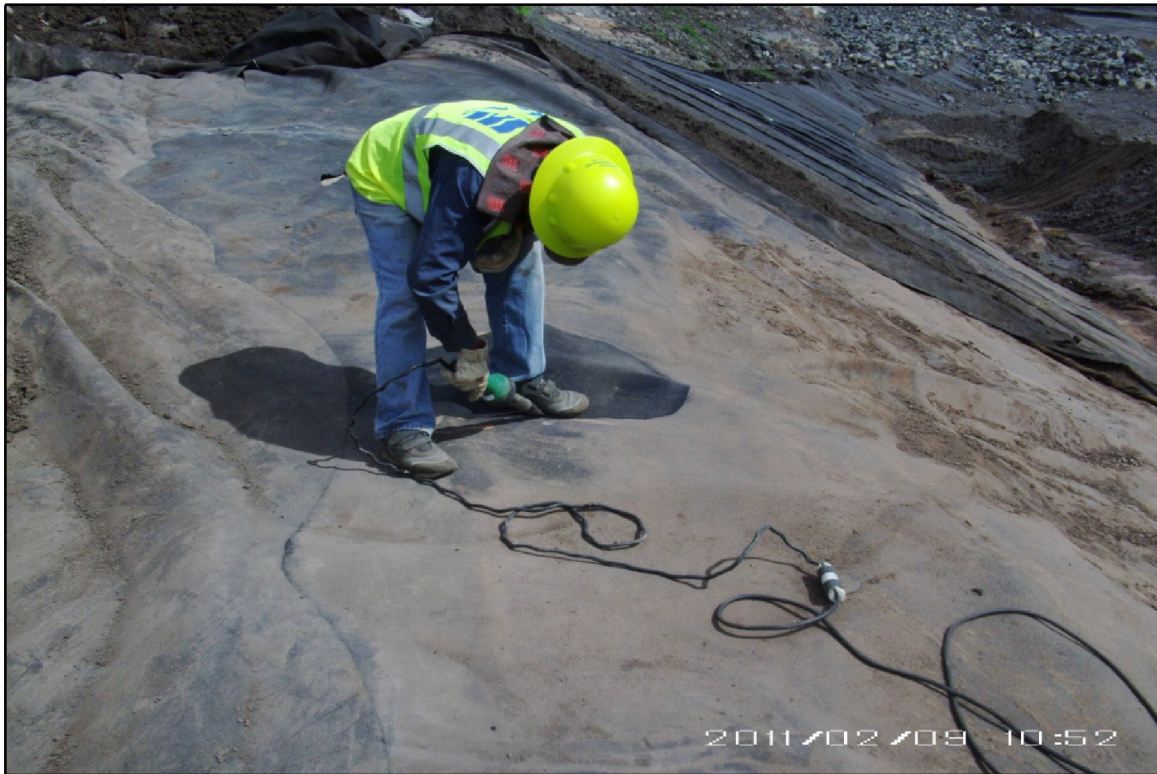
Photo 5: Heat tacking a repair patch on the 60-mil geomembrane.

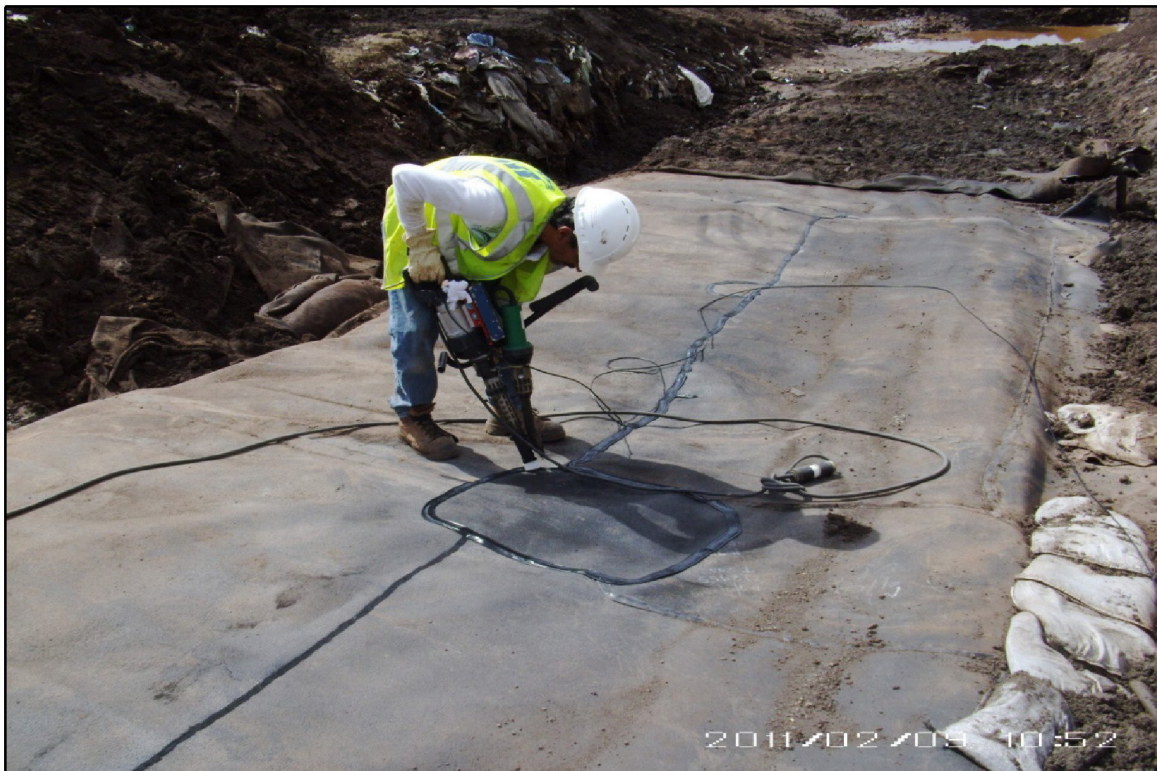
Photo 6: Extrusion welding of 60-mil geomembrane following repairs to remove wrinkles.

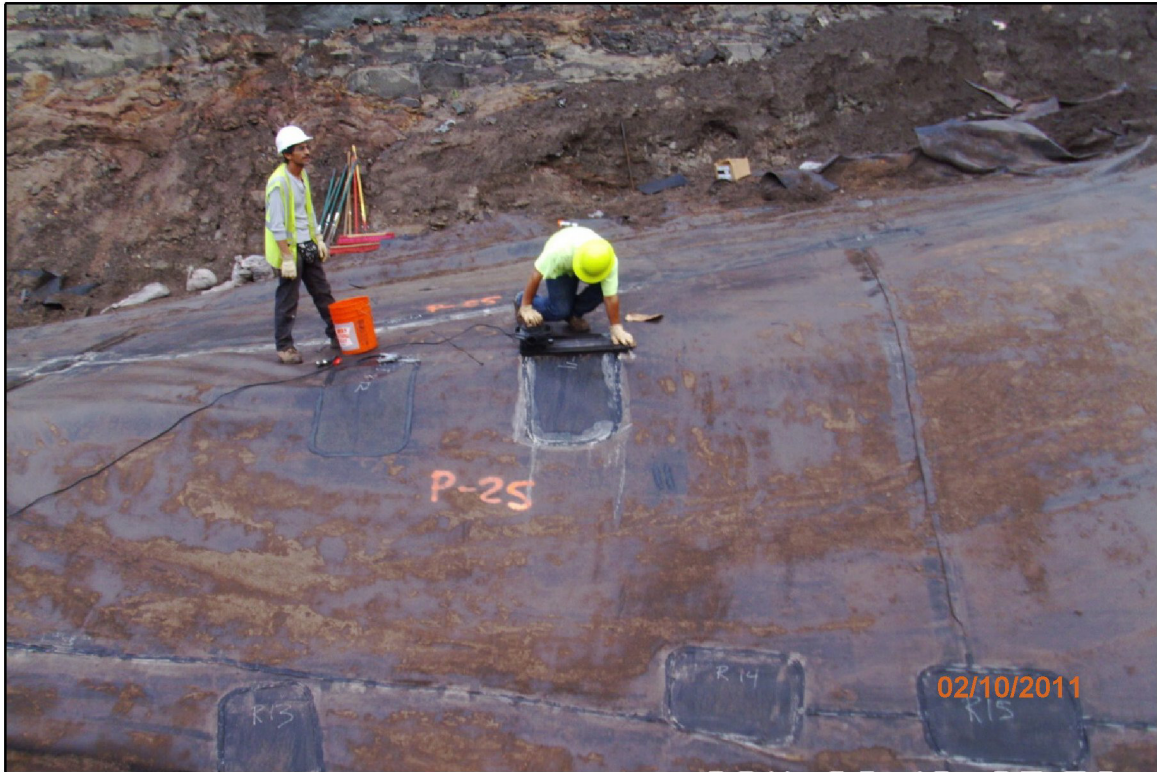
Photo 7: Non-destructive testing of a repair with vacuum box.

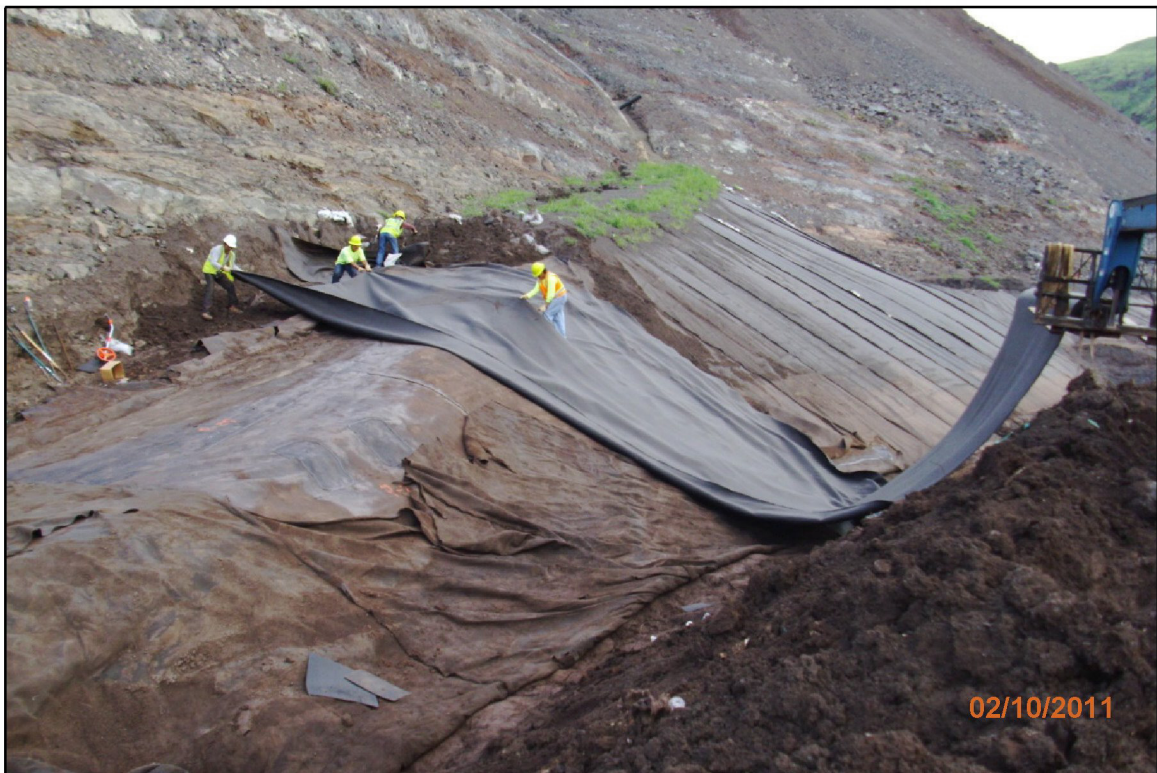
Photo 8: Deploying 16-oz/yd<sup>2</sup> geotextile following repairs to remove wrinkles.

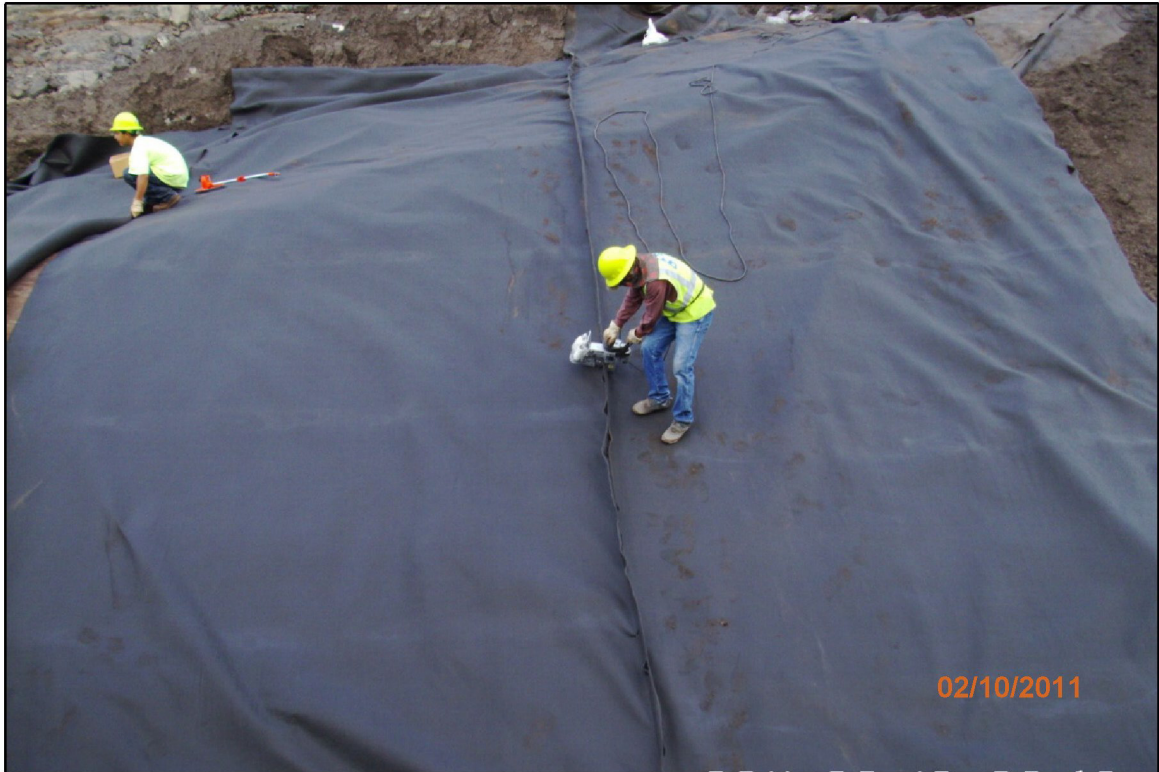
Photo 9: Sewing 16-oz/yd<sup>2</sup> geotextile following deployment.

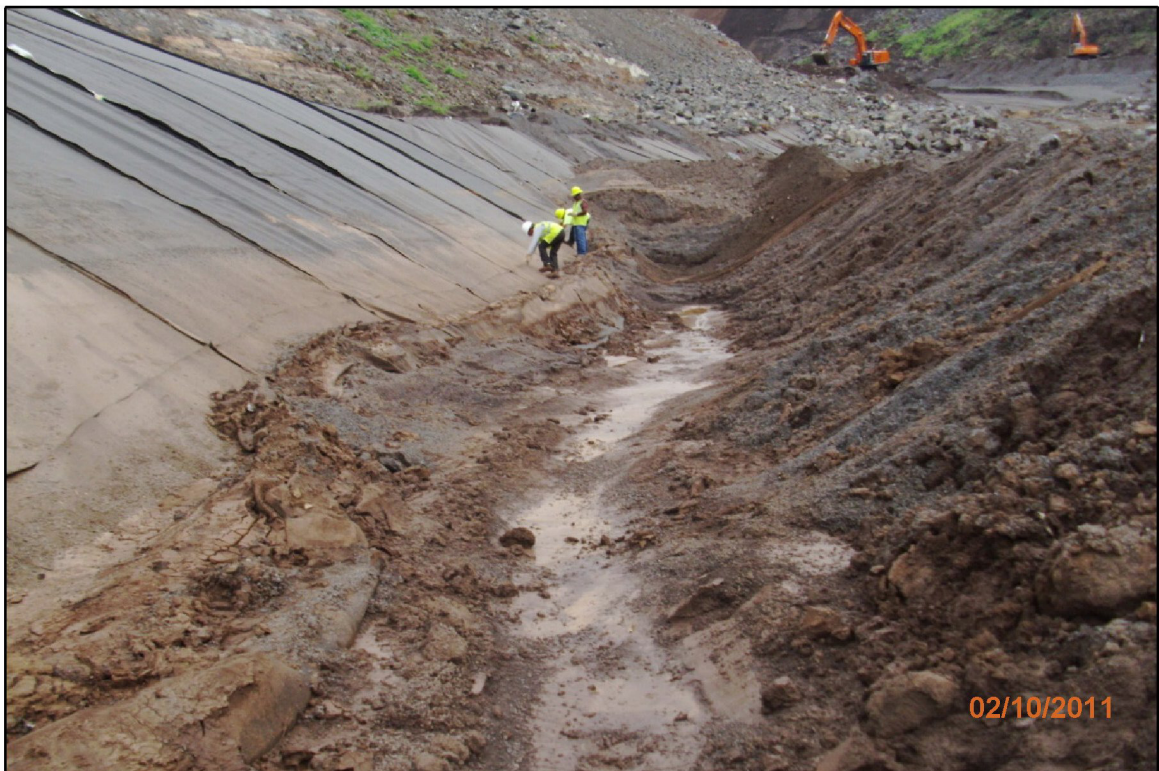
Photo 10: Exposing area with sediment under 16-oz/yd<sup>2</sup> geotextile and 60-mil geomembrane, looking north along the sideslope towards.

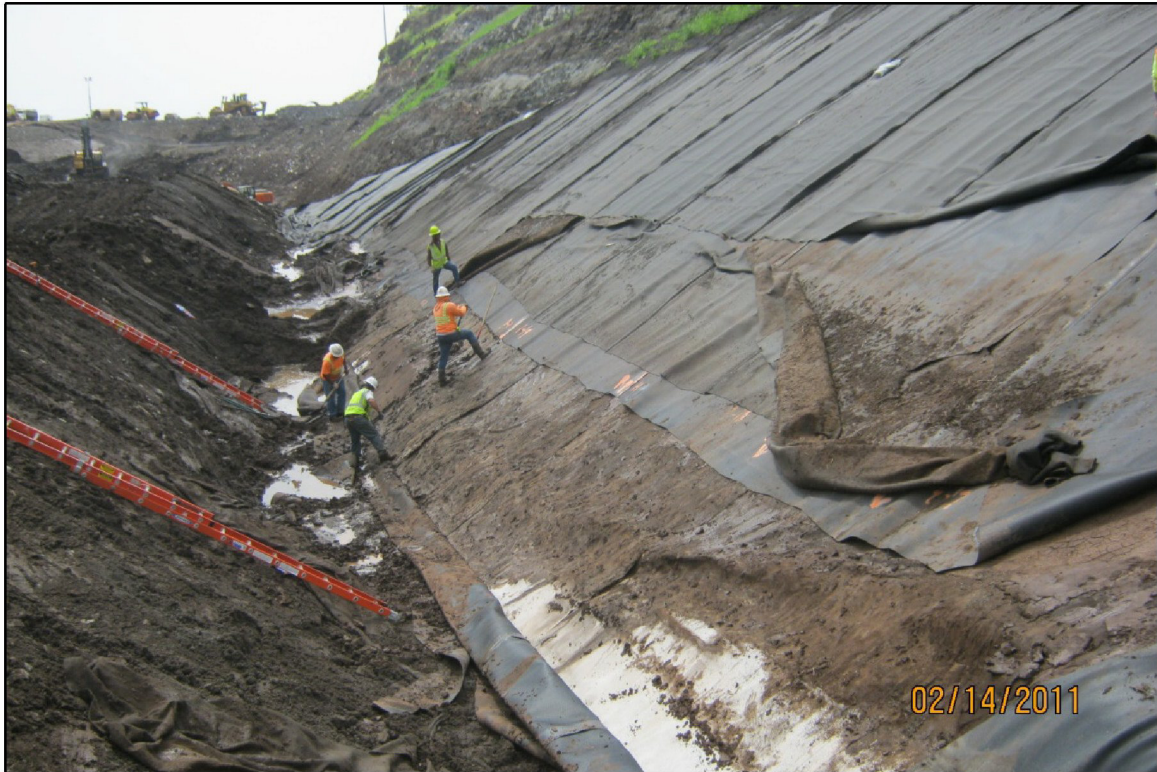
Photo 11: Removing sediment from between the 60-mil geomembrane and GCL along the sideslope.

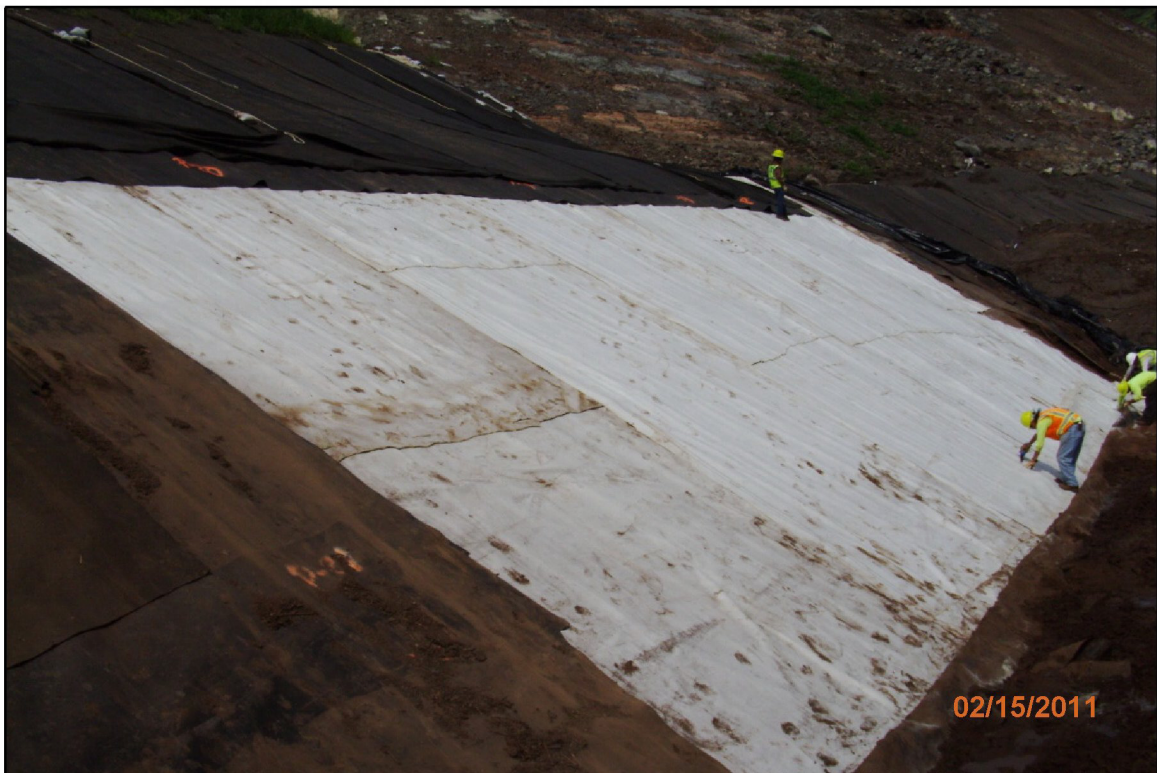
Photo 12: New GCL material following removal of hydrated GCL and sediment, looking north.

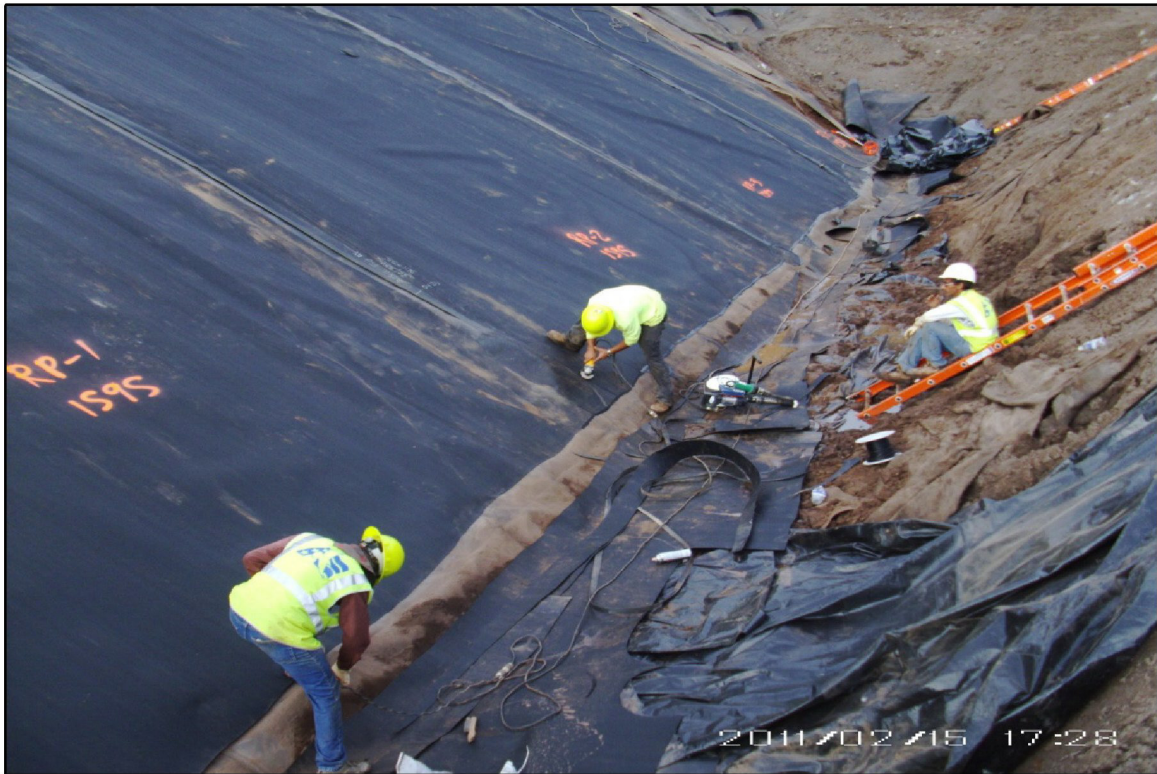
Photo 13: Preparing tie-in to existing 60-mil geomembrane following removal of sediment/hydrated GCL and deployment of new geomembrane.

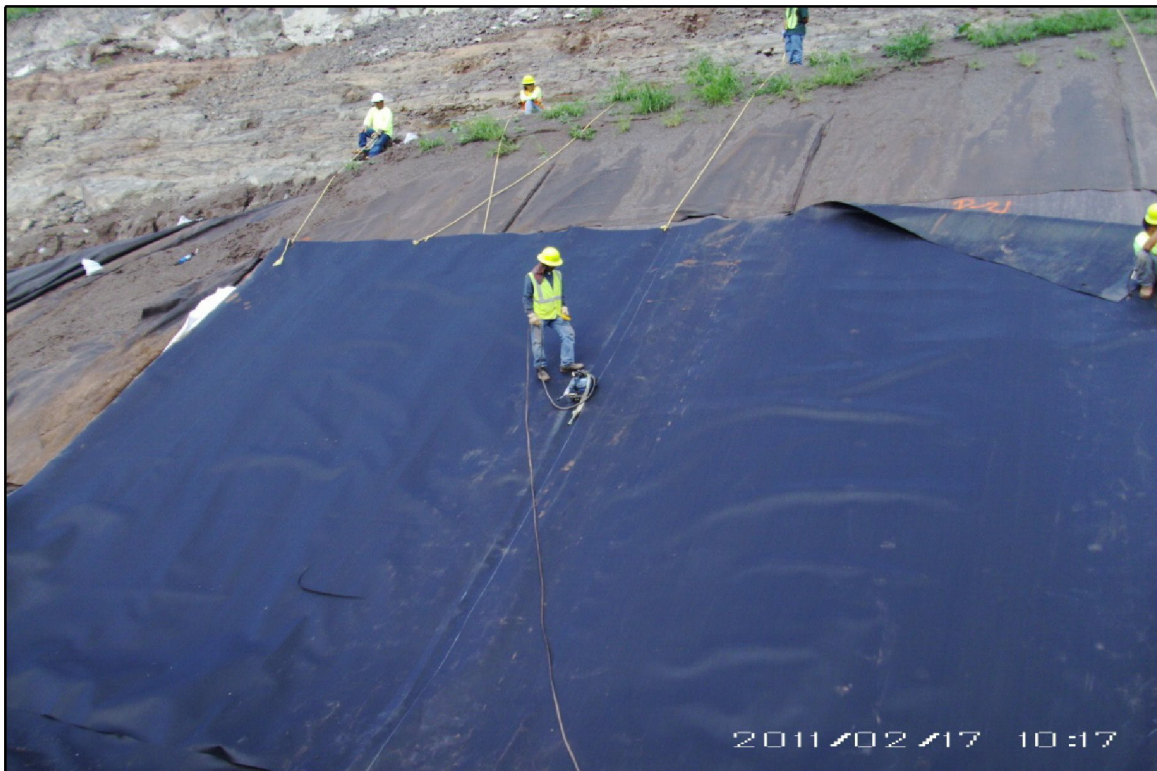
Photo 14: Fusion welding repair panels of 60-mil geomembrane following removal of sediment and hydrated GCL.

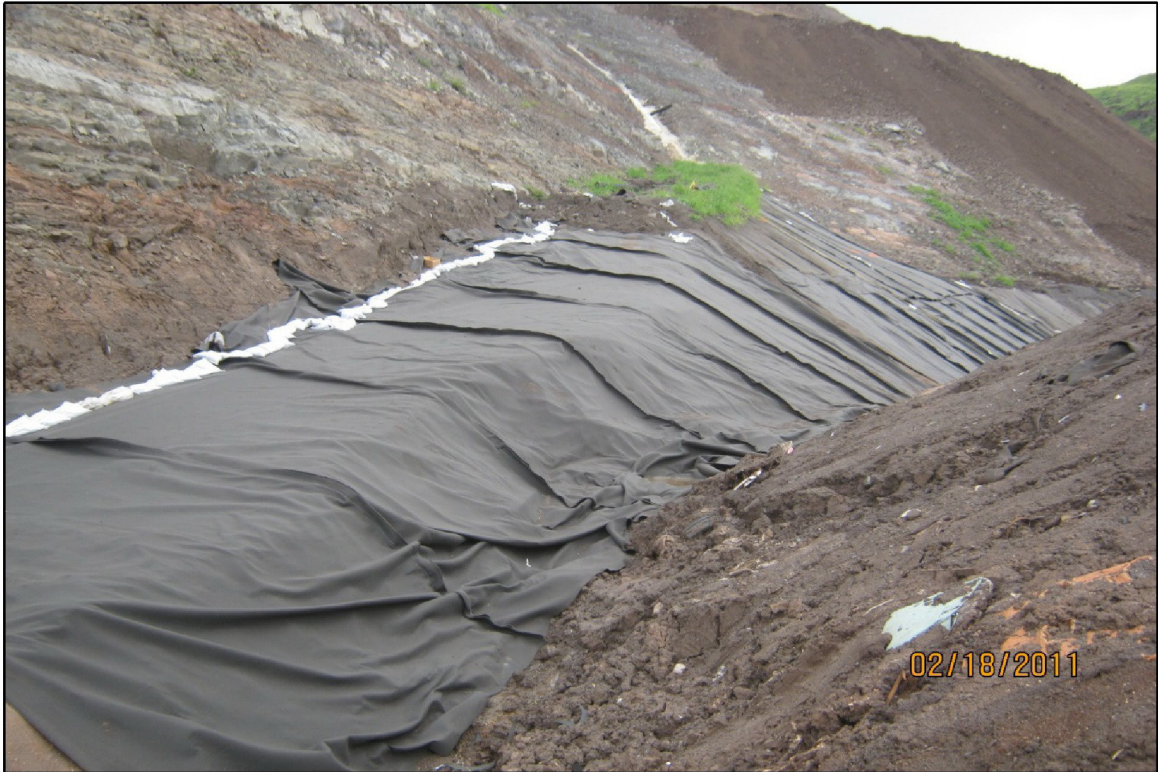
Photo 15: Overview of the southern portion of the repair area following removal of wrinkles and damaged liner system components, looking north.

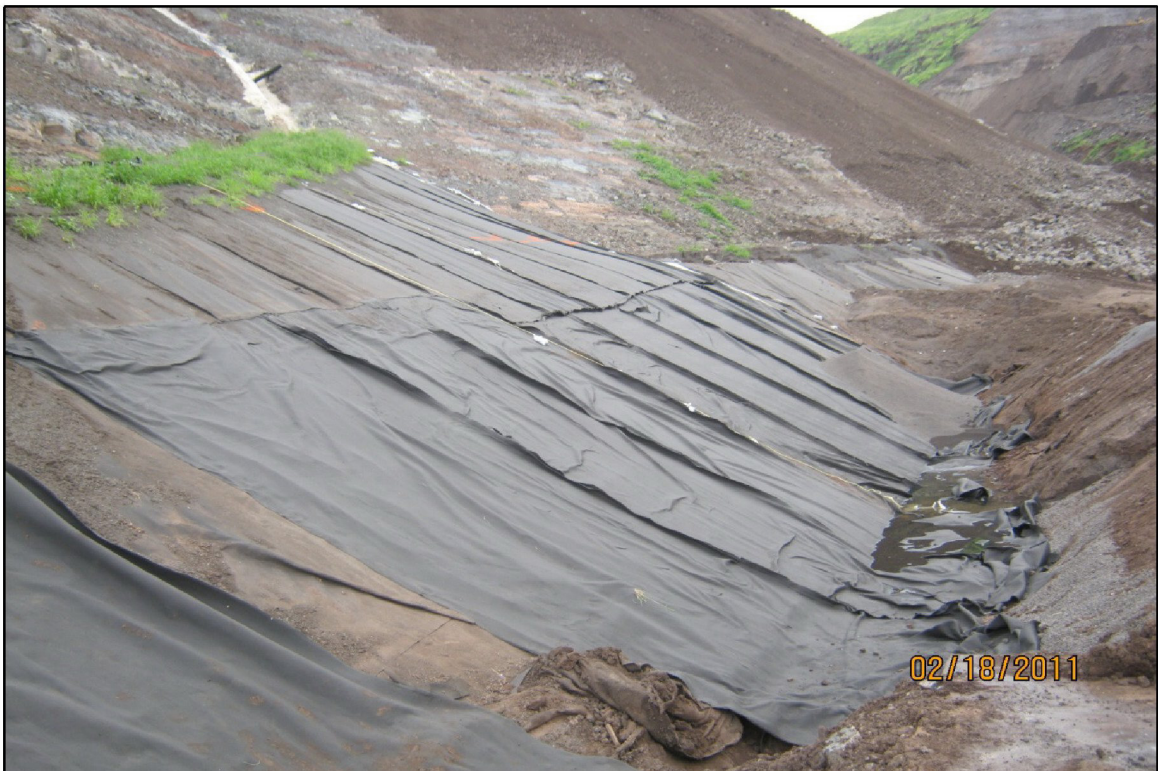
Photo 16: Overview of the northern portion of the repair area following removal of sediment and hydrated GCL.
